Malaysian Boeing 777 Flight MH17: Incident Report

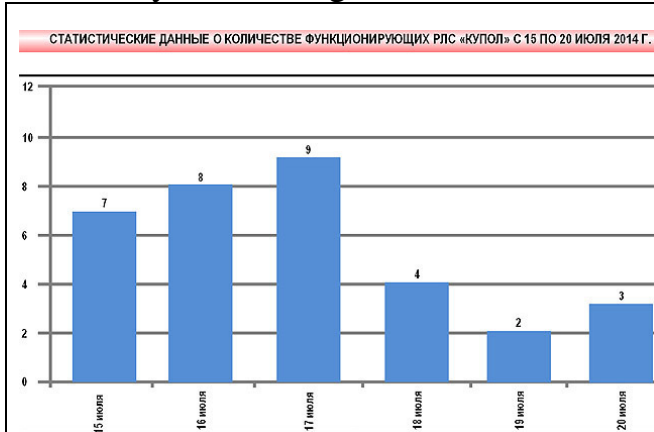
Fig.3 Statistic data of the activity of the Ukrainian Radar Location Stations in the area of catastrophe of Malaysian Boeing 777 flight MH17

7.1.2. The Russian Defense Ministry said that Russian military radar detected the "Dome" Ukrainian air defense system battery "Buk-M1",working, on the day of the Malaysian Boeing 777 disaster.

The activity of Radar Location Stations (RLS) can testify to the active deployment of military aviation insofar as the RLS is actively used for air reconnaissance and the transmission of information to the aviation control centre. It is common to provide data to assist the navigator in the coordination of single or groups of fighters to fulfil missions. Such missions include Air Superiority or ambush operations. In these missions an attack can take place either head on or in pursuit with co-ordination from the ground.

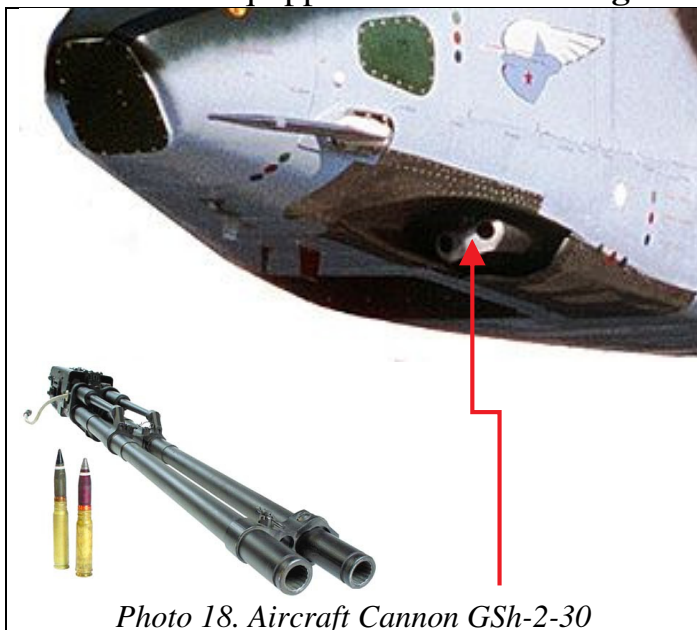
Photo 17. G-Sh310 Aircraft gun

The MiG-29 is equipped with a 30-millimeter GSh-301 cannon, firing at a rate of 1500 rounds per minute. This gun is loaded with 150 shells containing tungsten alloy. Its effective range for airborne targets is 200-800 m, for land-based targets, 1200-1800 m. This kind of projectiles pass through, leaving a track that is perfectly round in shape; they do not explode inside the cabin and are not incendiary, but they can kill the crew and destroy the cabin. The entry and exit holes exhibit a typical configuration. The entry holes show the edges pushed inside the opening; on the opposite wall, the edges are pushed outward.

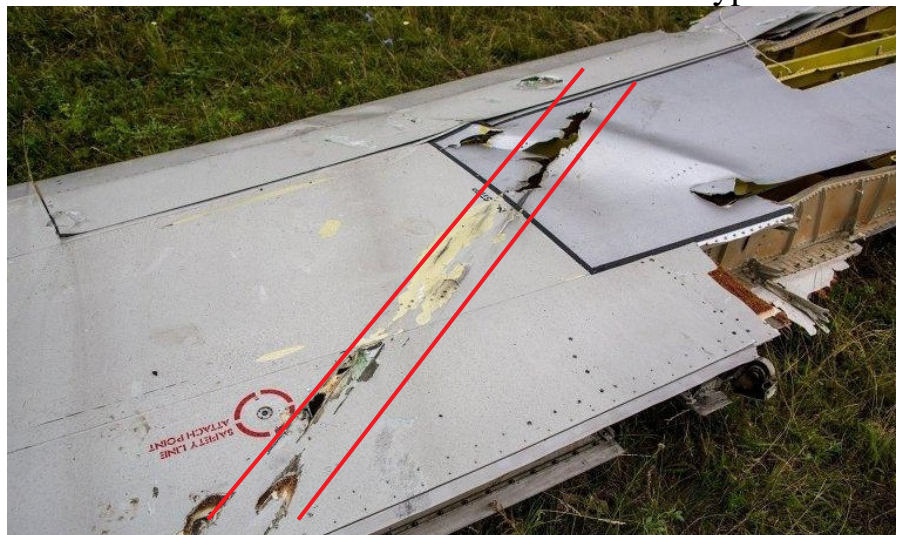
Photo 19. Damage to the flat surfaces of the Boeing 777

If we consider the first version of the crash, it is evident from the way the holes are arranged in the fragments of the flat surfaces and the fuselage that they do not reflect the typical picture of the impact of "Buk-M1" missiles, which would have left a very noticeable and characteristic pattern of damage marks. In this case, it is clear that there are no such traces on the debris fragments.

It would be logical to assume that the damage shown in photo 19 is more commonly associated with aircraft cannon shells of the GSH or SPPU type.

*Damage to the Boeing 777 is not characteristic of the SAM "BUK-M1" missile*
